Bat Report

Hunsbury Hill Centre, Northampton,

27th September 2006

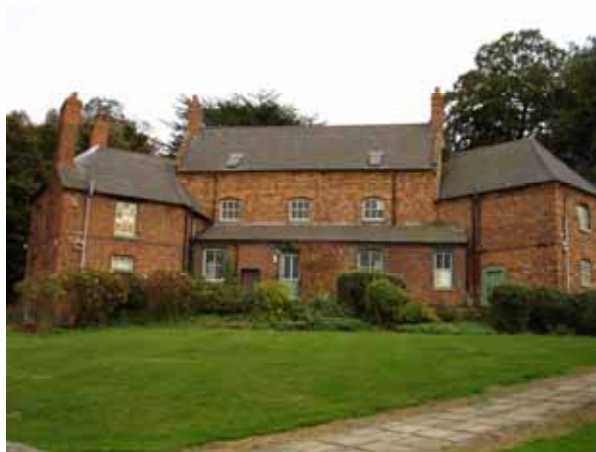
From west – facing farmyard

Roof void has a summer roost of whiskered/Brandt's bats. The signs (droppings) show that the roost has been present for a number of years. Favoured roosting place is where the hip rafters meet the ridge beam. Access point is likely to be from gaps under ridge tiles.

High probability of bat interest

Externally, a pipistrelle roost was discovered over the top of the upper floor end window (at extreme right on above photograph). The bats squeeze between the top of the frame and the brick lintel. This roost was active in early summer 2006.

- Bat roosts were discovered in the roof voids of both wings of the main farm-house, and another roost above the end window on the first floor of the south wing. Any work in these areas, such as roof repairs, window maintenance, electrical or plumbing works in the void will require advice and licences from the statutory nature conservation organisation, English Nature (soon to be called Natural England). Since mitigation is required it is best to seek this advice early on in the planning process as it could affect proposed works.

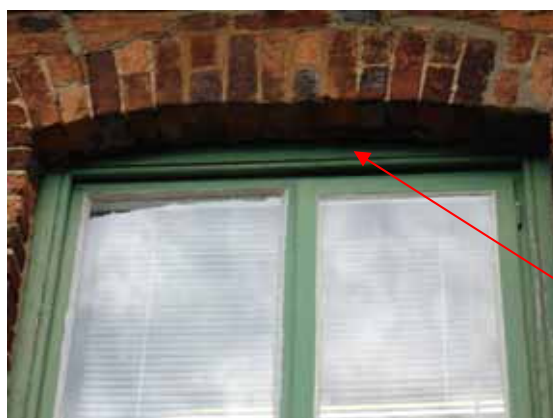
upper floor window – gap above frame

High probability of bat interest

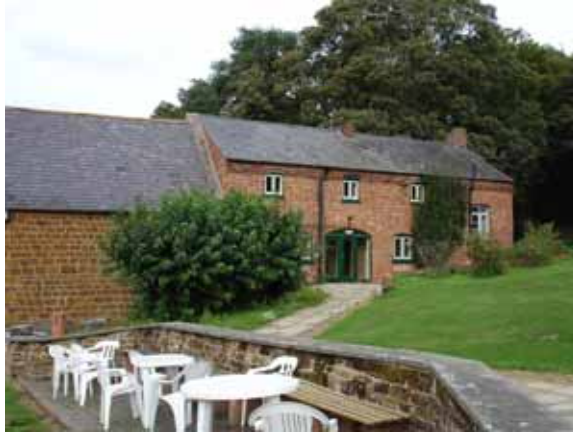
From south – right end of row

There is no human access into the roof void, so that area could not be checked for bats.

Internally, below roof level, no suitable day-roosting crevices were discovered.

Externally no suitable roosting crevices could be located.

Low probability of bat interest

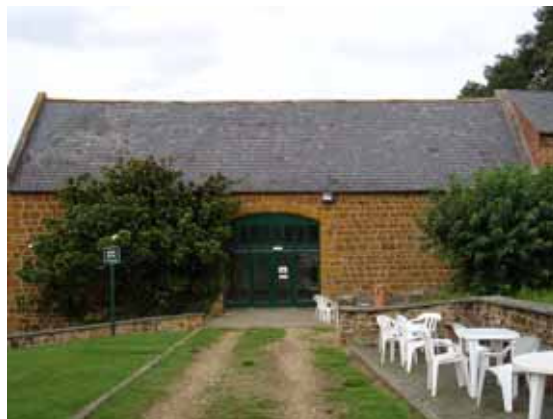
From south

A large barn in stone with an unlined slate roof. This old threshing barn has been converted to a large meetings room. It is open to the roof with a small void (1.5m

high) under the ridge. No signs of bats were found in the void. The rest of the building is unsuitable for bats and no signs were found. Externally there were few suitable crevices for bats to use for roosting and no signs of bats were discovered.

Low probability of bat interest

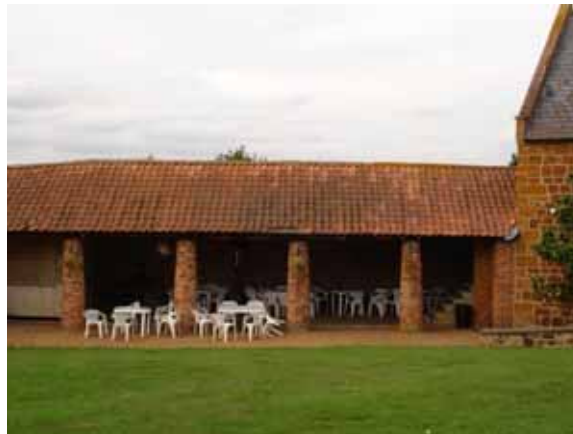
From south

A night-perch for a long-eared bat was discovered at the east end (prey remains). This area is well-used by the public so other signs may have been lost. No day-roosting places for bats were discovered inside or out.

Low/medium probability of bat interest

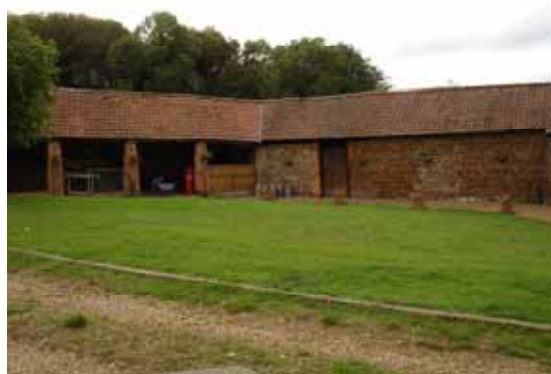
View from north-east - barn on right

A small night-roost for long-eared bats (prey remains found).
No day-roosting places for bats were discovered inside or out.

Low/medium probability of bat interest

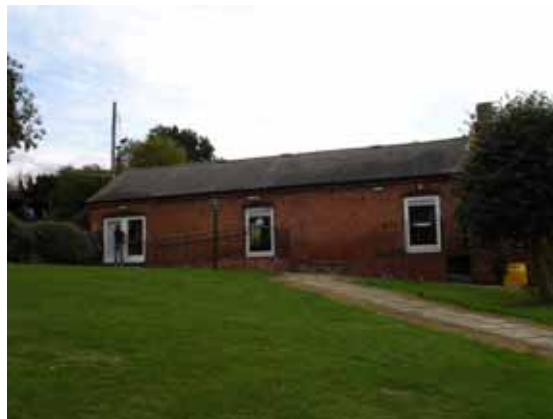
From north

The roof void over the kitchen (east end of building) is quite large, but no signs of use by bats were discovered. The void over the function room is very small (less than a metre in height) and is light. No signs of use by bats.
Externally no suitable roosting places for bats were discovered.

Low probability of bat interest

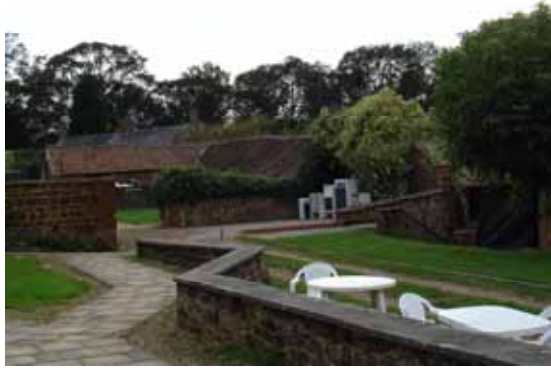
From north – stable on left

No signs of use by bats and no suitable day-roosting places inside or out.

Low probability of bat interest
